# The Atlanta Printmaker Studio

748 Virginia Avenue

## Project Financial Update and Recommendations

## **Overview**

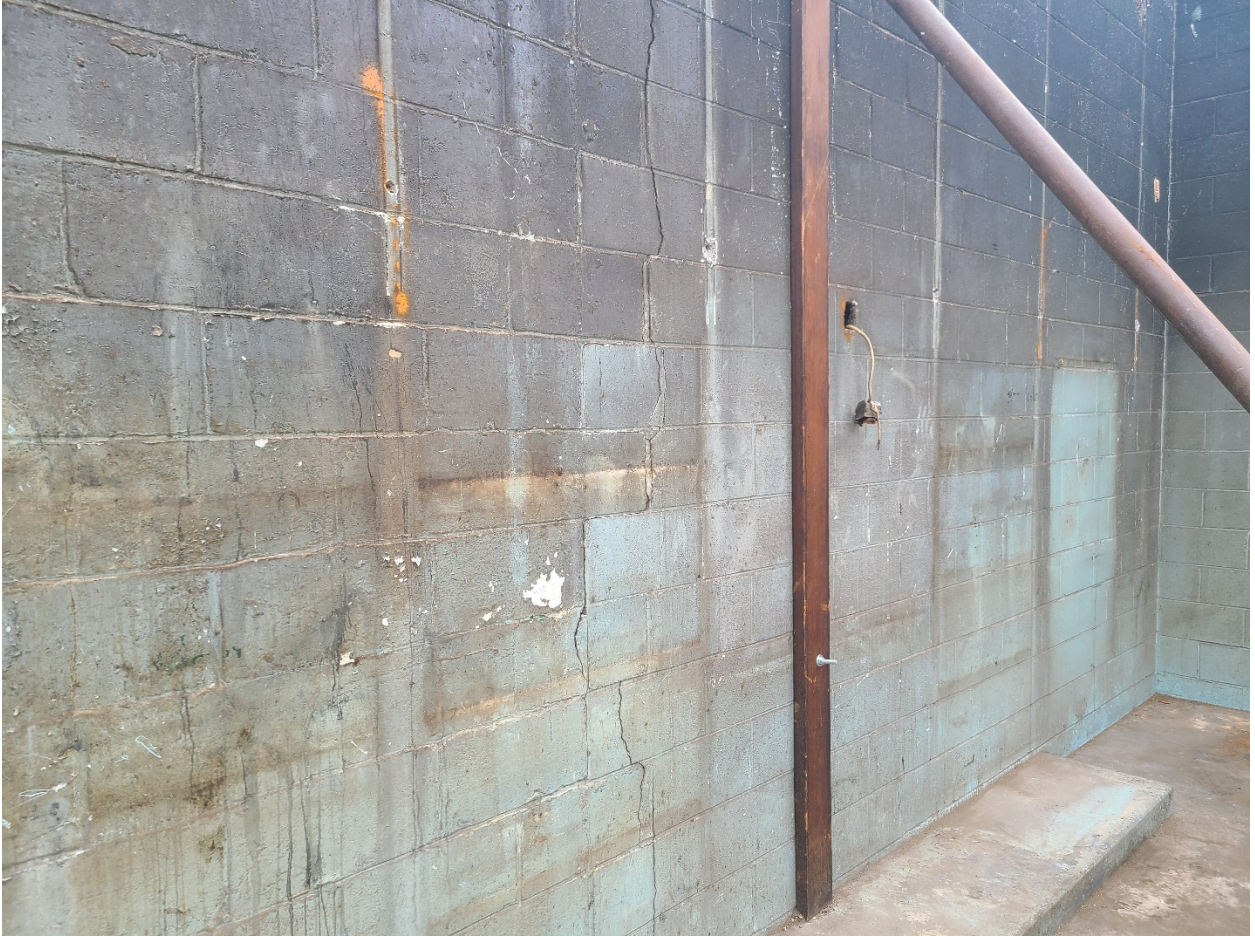
As removal of artifacts and interior demolition began, we uncovered a structural crack in the masonry wall of the east elevation of the existing building. Upon further investigation, it was determined that the crack occurred at the juncture of the originally constructed building, and an addition that was constructed at some point after the original building was built. Photo A below shows the condition.

Thermal movement or differential settlement between the original building and the addition likely caused the crack. The structural engineer reviewed the situation and determined that the integrity of the wall needed to be restored in order to safely carry the load of the roof. The following RFI #8 and accompanying design drawings indicate how the condition is to be addressed.

| <b>Question</b> | <p><b>Question from Khari Streets Paryani Construction on Friday, Nov 12, 2021 at 09:39 AM EST</b></p> <p>As reviewed in structural site visit dated 10/19/21, there is an existing CMU wall that needs to be repaired because of a stress crack caused by a previous fire. Per comments in that site visit and OAC Meeting dated 11/4/21, we are requesting the detail of the suggestion made by the structural engineer to remove face of block to reinforce the structural integrity of the wall with rebar and grout.</p> <p>Also, on that same date we reviewed the details of the 3" posts being installed at the Museum Area Storefront. Please provide a attachment details for how posts should be secured into the building. We also need an detail on what to do at condition at C-Channel.</p> |
| <b>Official Response</b> | <p><b>Response from Audrey Plummer Source Urbanism on Tuesday, Nov 23, 2021 at 05:09 PM EST</b></p> <p>The Structural Engineer has provided the attached details as a response to the RFI. Contractor is to refer to detail 1/S-2.2 for direction on the repair of the crack at the plan south wall. Contractor is to refer to detail 2/S-2.2 for the new steel post and base plate at the curved wall in the Museum. The exact post locations are forthcoming. These details will be officially issued in the forthcoming ASI-01 – 100% CD drawing set. Contractor to inform architect if further clarification is needed.</p> <p><b>Attachments</b><br/> <a href="#">20180-748 Virginia Ave Hapeville S-2 2 details.pdf</a></p> |

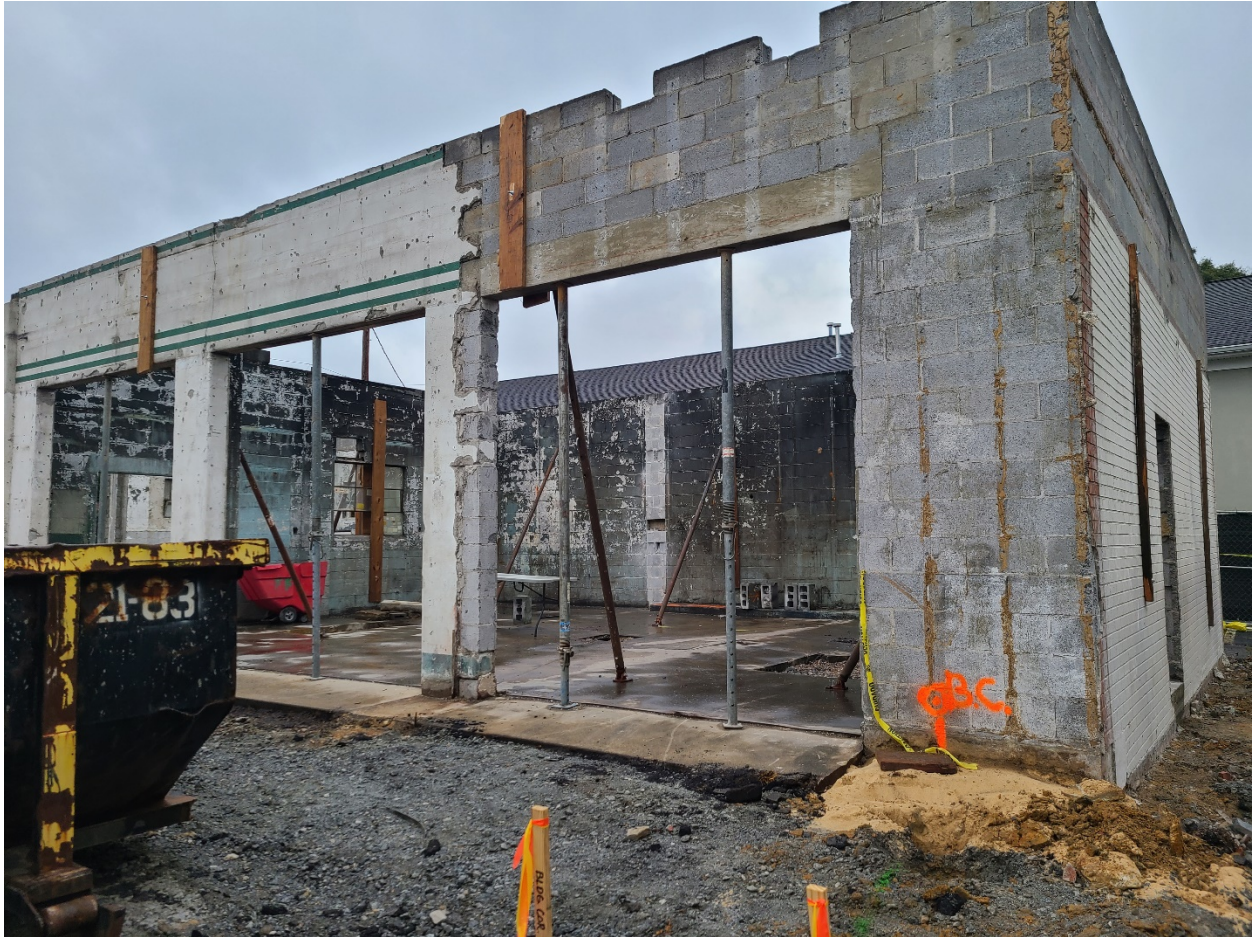
The condition of the masonry construction of the west wall of the existing building was investigated by the structural engineer after cracking was observed in the headers over the garage bay doors. While repairs to the numerous issues was considered, it was determined that a complete reconstruction of this section of the building would be more practical.

Photo B shows the location of the wall.

The following RFI #12 addresses the structural engineer's direction to address the condition.

| <b>Question</b> | <p><b>Question from Khari Streets Paryani Construction on Wednesday, Nov 17, 2021 at 01:48 PM EST</b></p> <p>As per site meeting that occurred on 11/17/21, there was a meeting to discuss the integrity of the existing plan north CMU wall in the garage area. Per our meeting we discussed demolition of this wall to be installed new. Please provide detail of how we should proceed at the existing plan north wall.</p> <p><b>Attachments</b><br/><a href="#">Plan North Rebuild Markup.pdf</a></p> |
| <b>Official Response</b> | <p><b>Response from Dawn Riley Source Urbanism on Thursday, Dec 2, 2021 at 07:48 PM EST</b></p> <p>Please see the attached architectural demo plan showing the revised demo scope for the plan north wall and the attached revised structural drawings showing the new construction scope. All changes have been clouded and tagged as ASI - 01. These sheets will be issued with the forthcoming ASI-01 - 100% CD drawing set. Additional information on the exact opening locations and heights will be included with the forthcoming drawing set.</p> <p><b>Attachments</b><br/><a href="#">2021_12_02 RFI 12 - Plan North Wall.pdf</a></p> |

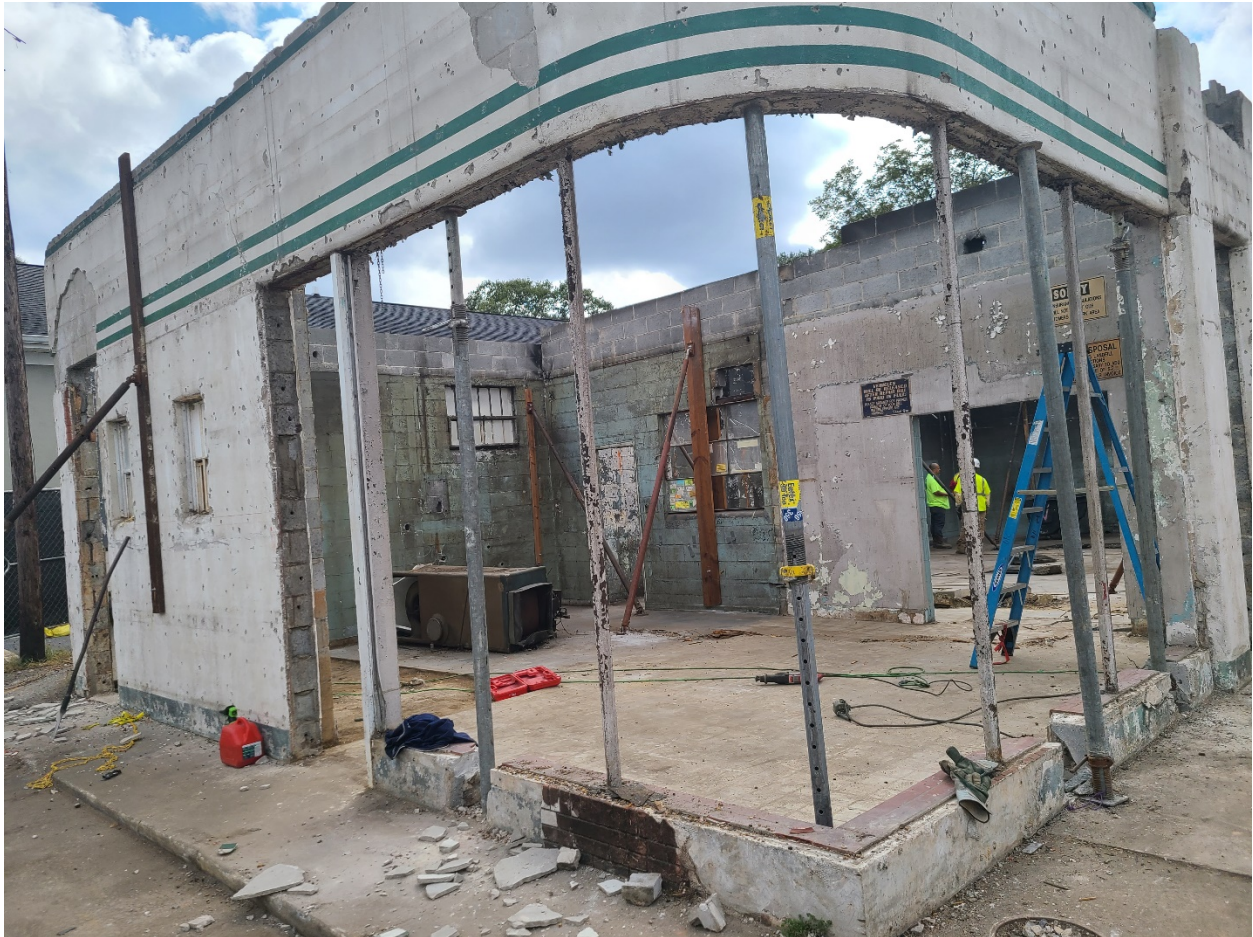
Photo C

The structural tube posts located at the northwest corner of the existing building were examined by the structural engineer and determined to be suspect in their condition to continue bearing the load of the structure on them. Further, the corner of the slab has cracked and needs to be repaired.

Photos C and D show the conditions in question.

The structural engineer determined that it was in the best interest of the project to replace these posts, and the supporting foundation on which they bear, and to repair the slab corner.

RFI 8 and 10 below address the engineer's direction to replace the posts and repair the slab.
